NASA TECHNICAL NOTE

NASA TN D-4807

FIRST U.S. MANNED SIX-PASS
ORBITAL MISSION
(MERCURY-ATLAS 8,
SPACECRAFT 16)

DESCRIPTION AND PERFORMANCE ANALYSIS

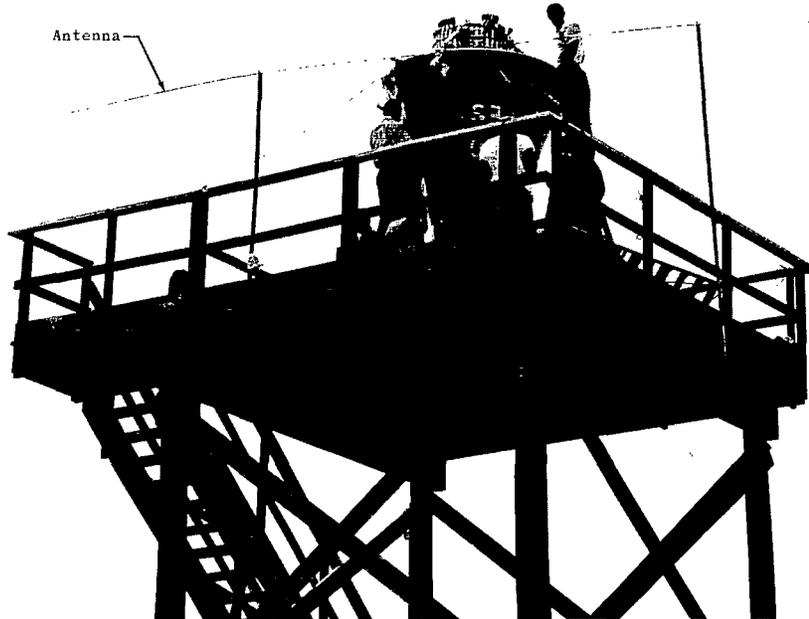
Figure 21. - High-frequency dipole antenna in the extended position.

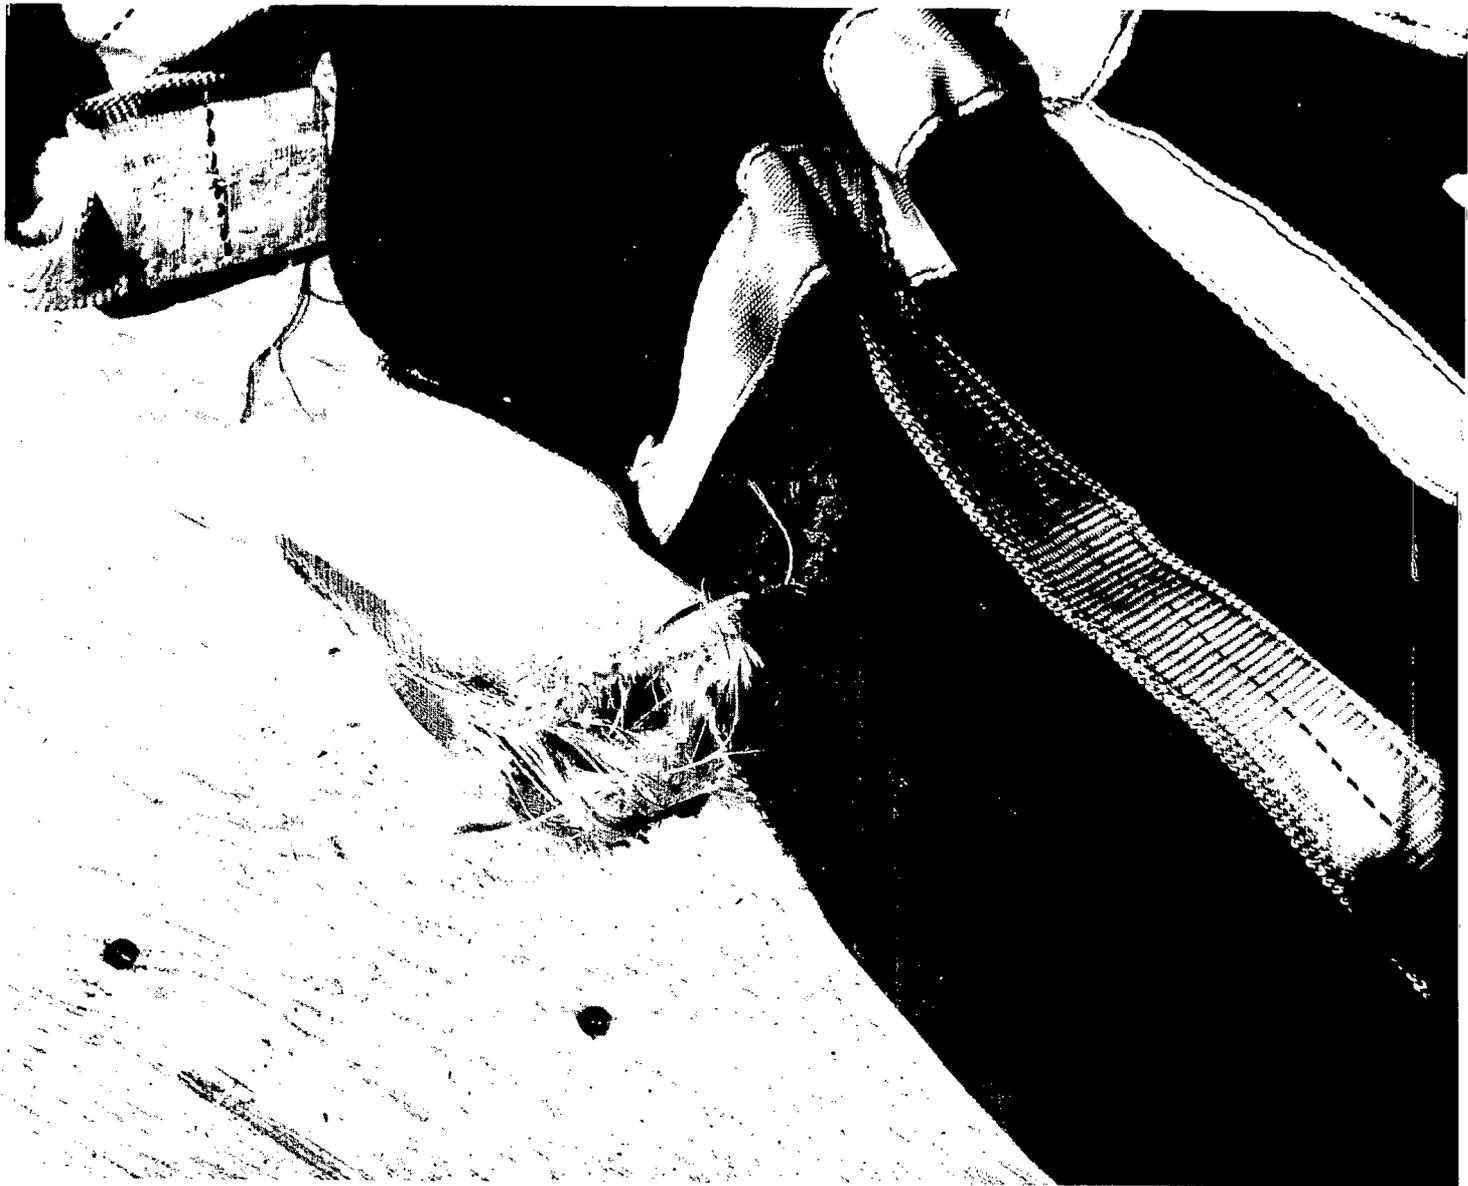
Figure 25. - Postflight photograph of main-parachute deployment bag showing tears.
